Record breaking toughness for strong posterior temporization.

Giovanni Molina Lugo, DDS, Mexico City, Mexico

Diagnosis and treatment planning: A patient visited the office with a long term PFM posterior bridge. Clinical examination revealed the PFM bridge had functional, mechanical, and biological problems. While a new posterior bridge restoration was being fabricated, a provisional restoration was created using 3M™ Protemp™ 4 Temporization Material.

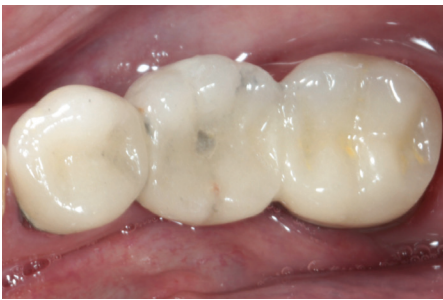
Fig. 1: Initial clinical situation.

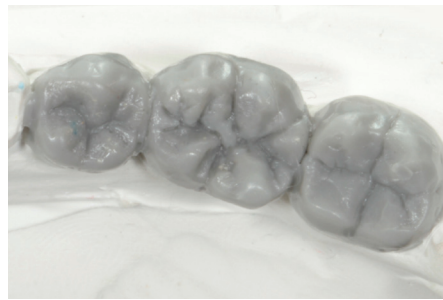
Fig. 2: After diagnostic impressions, an individualized diagnostic wax-up was performed.

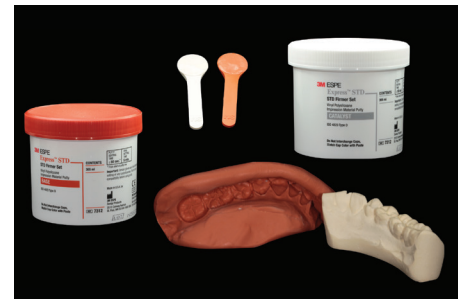
Fig. 3: An impression of the diagnostic wax-up was taken using 3M™ Express™ STD Putty. A stone model of the wax-up and a vacuum form matrix was created.

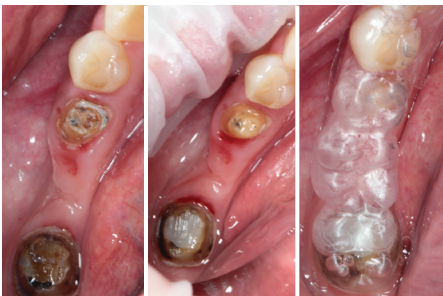
Fig. 4: After removal of the PFM bridge, the vacuum form matrix was placed and verified on the prepared natural abutments.

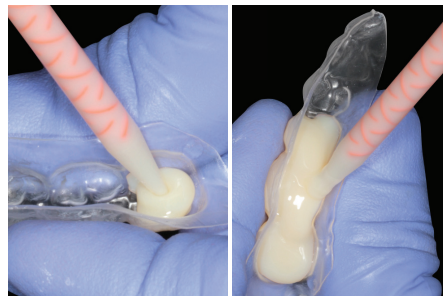
Fig. 5: 3M™ Protemp™ 4 Temporization Material was dispensed into the vacuum form matrix.

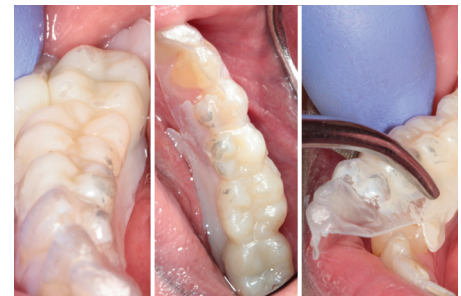
Fig. 6: The matrix with the temporary material was placed in mouth. Due to its transparency, it was possible to check the fit.

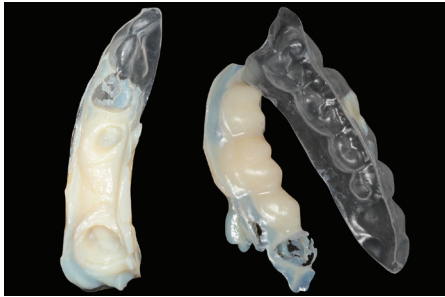
Fig. 7: The matrix was removed after the recommended setting.

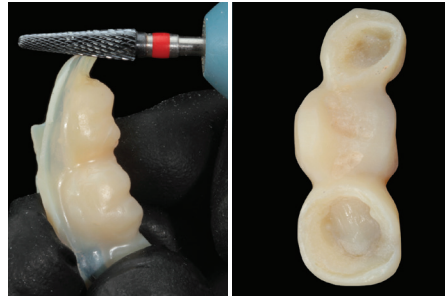
Fig. 8: The excess material of the new provisional bridge was trimmed.

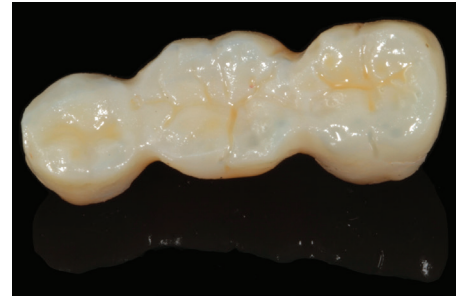
Fig. 9: Finished provisional bridge.

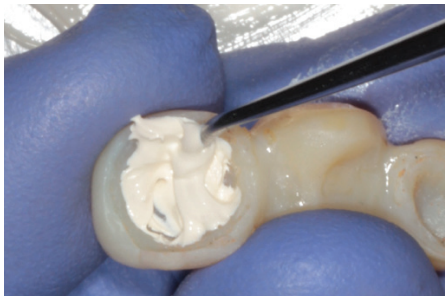
Fig. 10: 3M™ RelyX™ Temp NE Cement was used for temporary cementation.

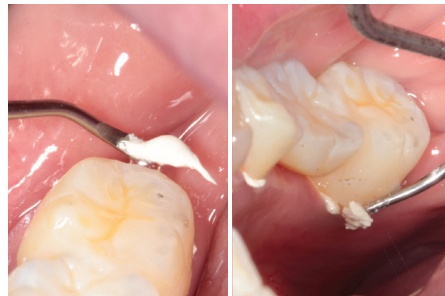
Fig. 11: Excess removal of the temporary cement.

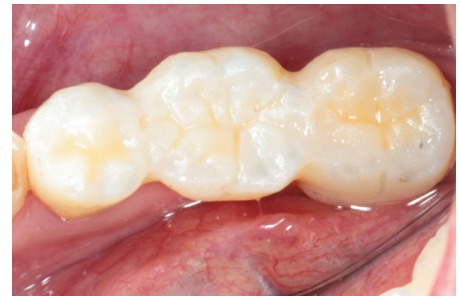
Fig. 12: Final 3M™ Protemp™ 4 temporary bridge in place.
