V.A.C.[®] Peel and Place Dressing

Collection of case studies

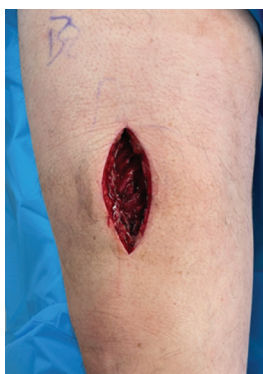
Figure 1. Open wound two days after incision and drainage of an abscess on the right thigh.

After the initial incision and drainage of the abscess, the patient was treated with cefazolin and conventional negative pressure wound therapy to manage purulent exudate. Repeat irrigation and debridement of the abscess was performed two days later, resulting in an open wound of 11 cm length x 4 cm width x 4 cm depth (**Figure 1**).

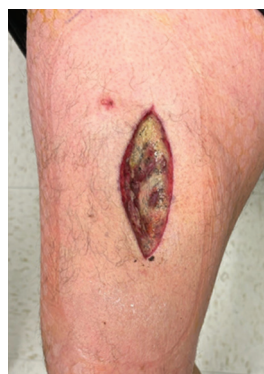
Figure 3. The first dressing change was performed after one week of therapy.

After one week of therapy, the V.A.C.® Peel and Place Dressing was easily removed, with no pain reported and no pain medication used. The periwound skin looked healthy, and wound depth had a 1.5 cm improvement (**Figure 3**). No debridement or cleansing was needed before application of the second V.A.C.® Peel and Place Dressing. The next dressing change occurred after seven days, and the third V.A.C.® Peel and Place Dressing was applied by a home care provider with no complications reported. At the scheduled follow-up, four days later, the wound bed had increased granulation tissue and appeared ready for closure after 18 days of V.A.C.® Therapy using three total V.A.C.® Peel and Place Dressings (**Figure 4**). Repeat irrigation and debridement were performed in preparation for surgical closure of the wound, and Prevena™ Therapy was applied over the closed incision.

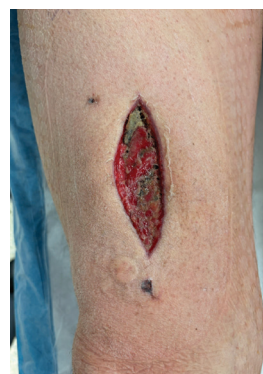
Figure 4. After three weeks of therapy using V.A.C.® Peel and Place Dressing, the wound appeared ready for surgical closure.

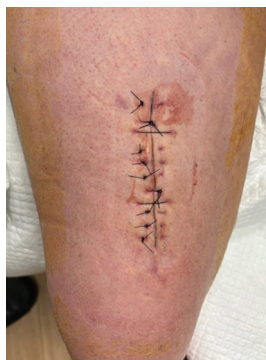
Figure 5. Closed incision after four days of Prevena™ Therapy.

After four days, Prevena™ Therapy was discontinued and wound management transitioned to dry dressings (**Figure 5**). Follow up visits at 10 days and two weeks after surgical closure showed wound improvement. The stitches were removed after three weeks, and the patient was discharged from treatment (**Figure 6**). The patient provided a follow-up photo three months after initial treatment and the wound had healed well (**Figure 7**).

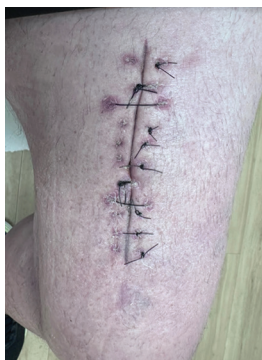
Figure 6. Sutures were removed three weeks after surgical closure.

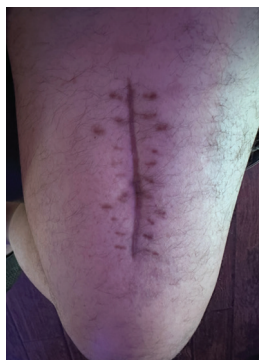
Figure 7. Three months after presentation.

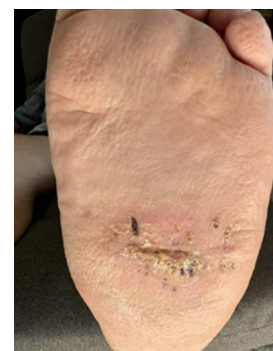
Figure 3. Wound closure achieved three months after Charcot foot reconstruction.

V.A.C.® Therapy with V.A.C.® Peel and Place Dressing resulted in decreased wound depth and formation of healthy granulation tissue. This helped prepare the wound bed for successful Charcot foot reconstructive surgery with a frame. 3M™ Promogran™ Collagen Matrix with ORC and Silver was applied after the Charcot reconstruction procedure and wound closure was achieved within three months (**Figure 3**).

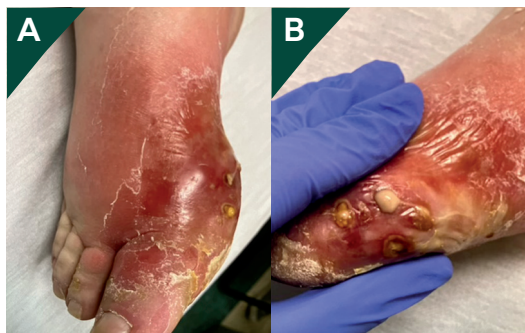
Figure 1. Diabetic foot infection of the right foot at presentation. A. Dorsal view B. Lateral view.

A 41-year-old female presented to the emergency department for a complicated diabetic foot infection (**Figure 1**) that required amputation of the first ray of the right foot (**Figure 2**). The patient had a history of neuropathy, hypertension, diabetes, hypercholesterolemia, and anaemia.

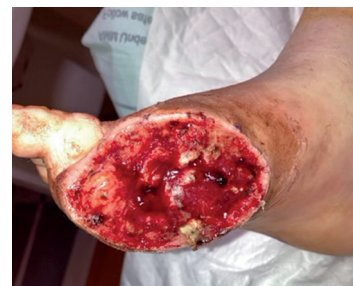
Figure 2. Wound one day after amputation of the first ray of the right foot.

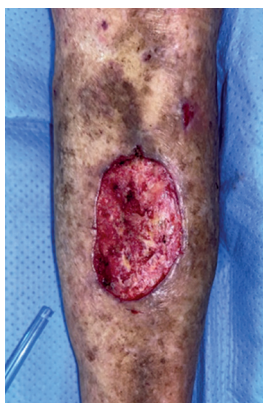
Figure 1. Wound after excisional debridement.

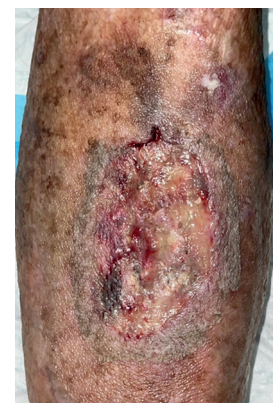
Figure 4. After seven days, graft take was good and V.A.C.® Therapy with V.A.C.® Peel and Place Dressing was discontinued.

The dressing was removed after seven days of therapy. Good graft take and some fibrinous proteinaceous material were observed (**Figure 4**). There was minimal exudate and the periwound skin was healthy. No adverse events or complications were observed. V.A.C.® Therapy was discontinued as therapy goals had been met.

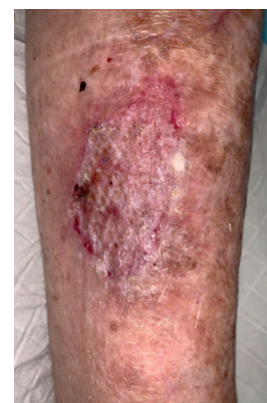
Figure 5. 30 days after STSG.

The wound was cleansed with a chlorhexidine gluconate solution. A gauze dressing, impregnated with petrolatum and bismuth tribromophenate, was applied over the wound and secured with an elastic bandage wrap. The wound appeared almost fully healed at the follow-up visit 30 days after the STSG procedure (**Figure 5**).
